German History in Documents and Images

Volume 9. Two Germanies, 1961-1990 Sketch of an East German Border Fortification (1984)

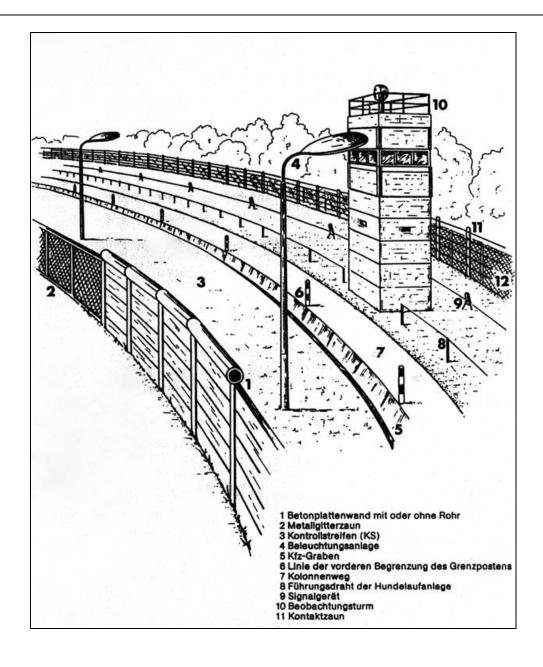
East Germany strengthened its border fortifications in response to ongoing flight attempts. The original barbed wire barrier was replaced by a massive concrete wall that was supplemented by control towers, flood lights, car tracks, guard dogs, spring guns, and an electric fence.

English key: 1) Concrete wall with or without pipe on top; 2) Metal latticework fence; 3) Checkpoint area; 4) Lighting system; 5) Anti-vehicle trench; 6) Line marking the front boundary of the border patrol; 7) Column track; 8) Wire run for guard-dogs; 9) Signal or warning light; 10) Observation tower; 11) Electric fence
